Project Inspection Sheet

3605 Hendrick Drive

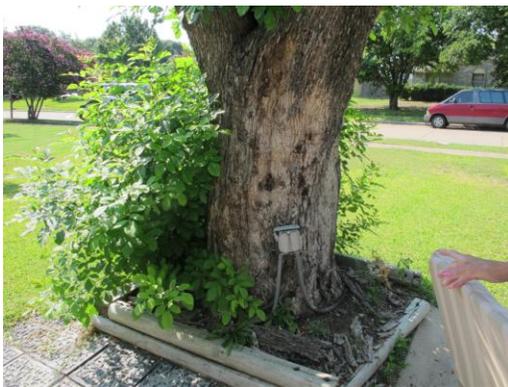
Tree removal require

To level of electrical box

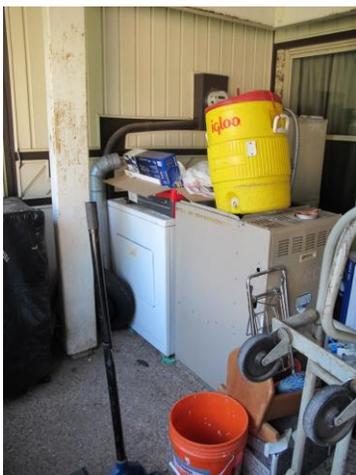
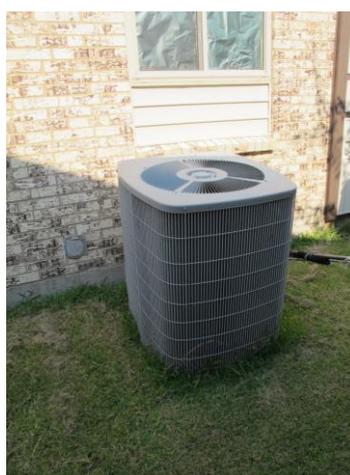
Dryer and furnace removal, and AC condenser removal needed, its not hooked up.

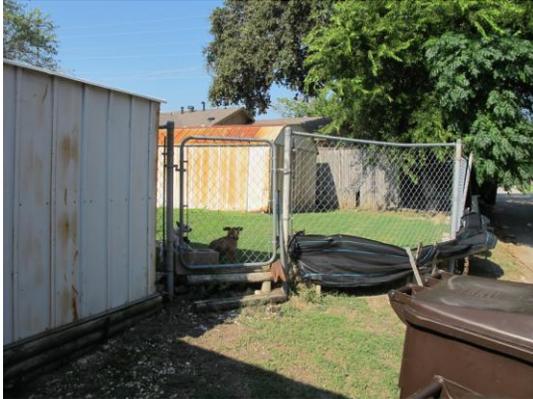
Fence and retaining wall repairs

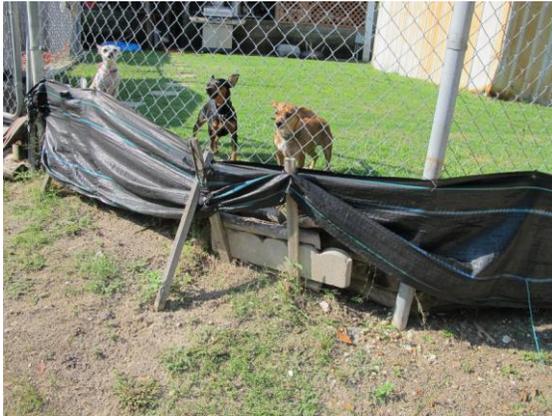
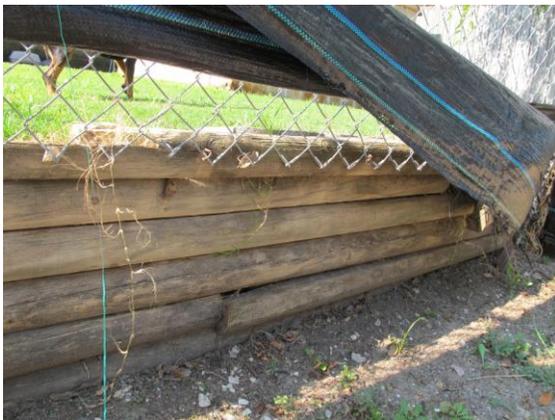
Wood removal and replaced with retaining wall bricks

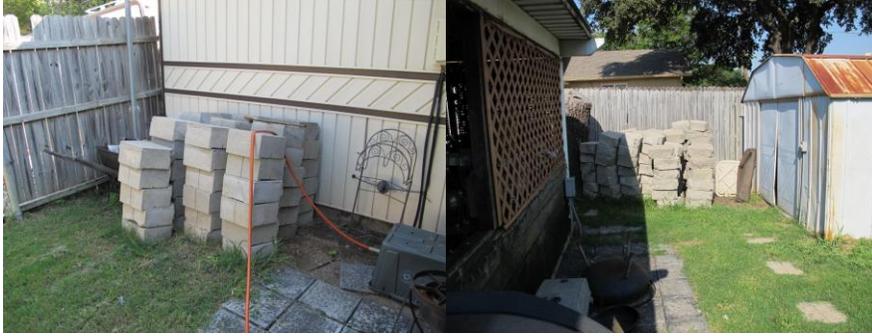
Retaining wall bricks to be used for repairs, owner stated that amount needed was measured and there should be enough.

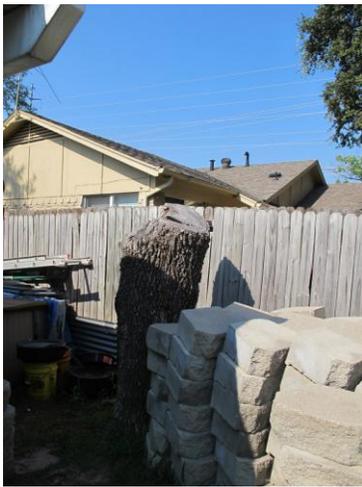
Tree removal from back yard

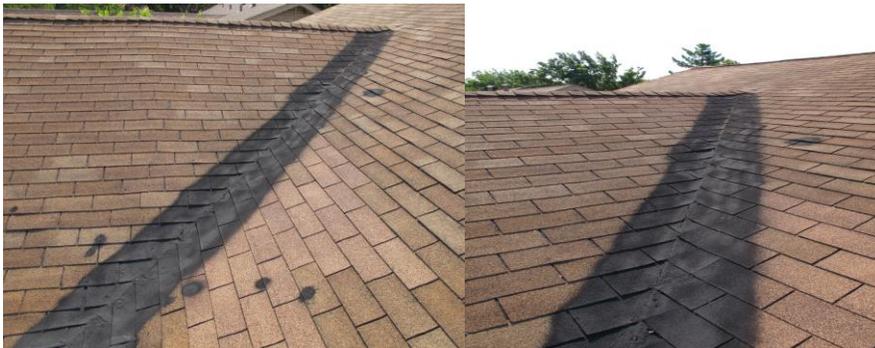
Roof leaks in this area. Wood is soft and rotted underneath.

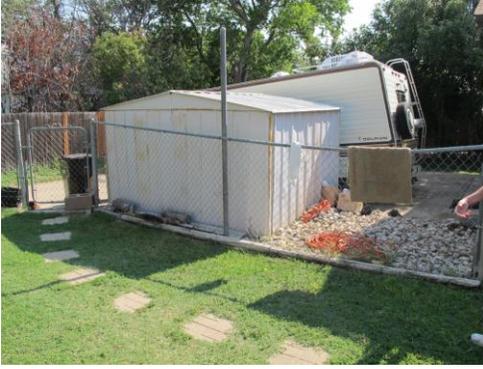
Owner requests that the gate be moved to the right of this shed.
